A Condition Assessment of Trees Located at the Western End of
'Duncairn Terrace' to the Front of 'Tesco Express', Quinnsboro
Road, Bray, Co. Wicklow.

Prepared for: Bray Tidy Towns Committee

Prepared by: Felim Sheridan (F.Arbor.A, RFS Dip. Nat. Dip & NCH in Arboriculture)

Date: 15th March 2021

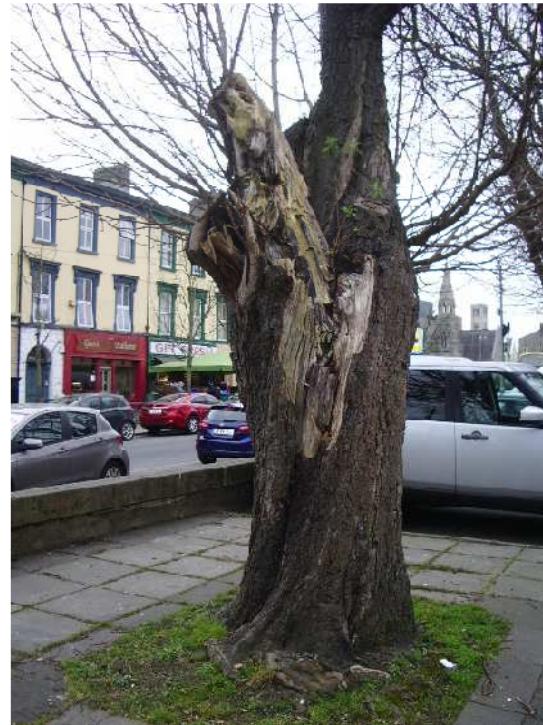
Tree No. 0725

Tree No	Tree Species	Age Class	Phy Con	Structural Condition / Comments	Recommendations
				Phy = Physiological	
0725	Horse Chestnut <i>Aesculus hippocastanum</i>	Mature	Fair / Poor	<p>Poor</p> <p>It is growing within a paved area and was initially twin-stemmed from a height of c. 1.6m up; however, one stem has broken out from this point, leaving its crown very asymmetrical as a result. There is a large area of decay on the main trunk at this tear wound and this decay is progressing into the main trunk creating an unstable tree. Its crown size has been reduced in the past and is re-growing from this to its current size. There are some areas of liquid exudation/ bleeds present on the main trunk indicating towards infection by 'Bleeding Canker' of Horse Chestnut.</p>	<p>I would recommend its <u>removal</u> as the most appropriate management option.</p> <p>Remove stump and replant with a new tree.</p>

- 5.1 From our assessment of these seven trees, we are now recommending the removal of **Tree Nos. 0725 & 0729** both mature Horse Chestnut trees due to serious structural issues caused by decay within their lower main trunks and bases. It is our professional opinion that the decay in both these trees is very advanced and pruning to address these issues would have a negative impact on them visually, and it would still be necessary for their removal short-term solution. I would recommend their removal now including their stumps along with replacement tree planting into this line of trees so as to help rejuvenate the tree line and to secure it for the future.

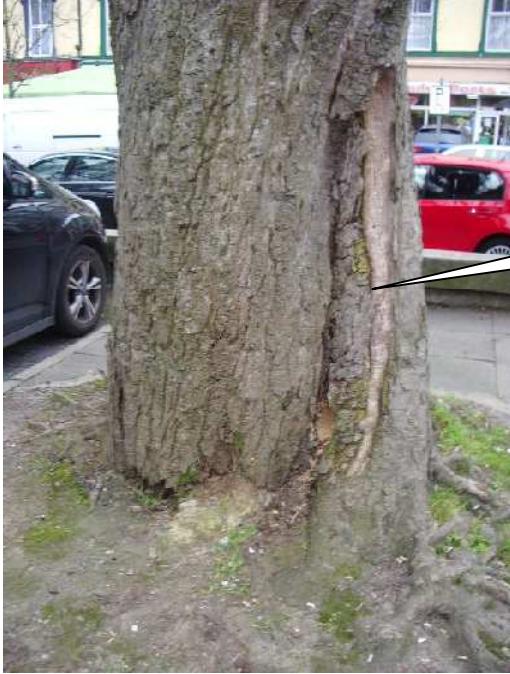
0729	Horse Chestnut <i>Aesculus hippocastanum</i>	Mature	Fair	<p>Poor</p> <p>It is growing out of a small opening within a paved area surrounded by walls and tarmacadam outside of this. It has a broad spreading crown formation and has been heavily reduced back in recent years and it is developing a new crown of growth from these pruning points. There is an extensive area of basal decay present and this encompasses c. 70% of the circumference. The decay at this point is quite deep and is extending into its base/ roots and as a result the safety and stability of this tree is of concern.</p>	<p>Due to its condition and structure, I would recommend its <u>removal</u> as the most appropriate management option.</p> <p>Remove stump and replant with a new tree.</p>

0729	Horse Chestnut <i>Aesculus hippocastanum</i>	Due to its condition and structure, I would recommend its <u>removal</u> as the most appropriate management option. Remove stump and replant with a new tree.	
0730	Lime <i>Tilia sp.</i>	Remove dead/ unstable growth from within its crown. Maintain basal suckers and remove lower epicormic growth in order to improve clearance over the surrounding surfaces. Its crown size will require management in the future.	
0731	Sycamore <i>Acer pseudoplatanus</i>	Remove dead/ unstable growth and cut ivy at ground level. Monitor its condition on a twelve monthly basis.	
Notes:
