Swan River, Bray

Freshwater Ecology Survey &
Biodiversity Management Plan

March 2023

Final Version 01

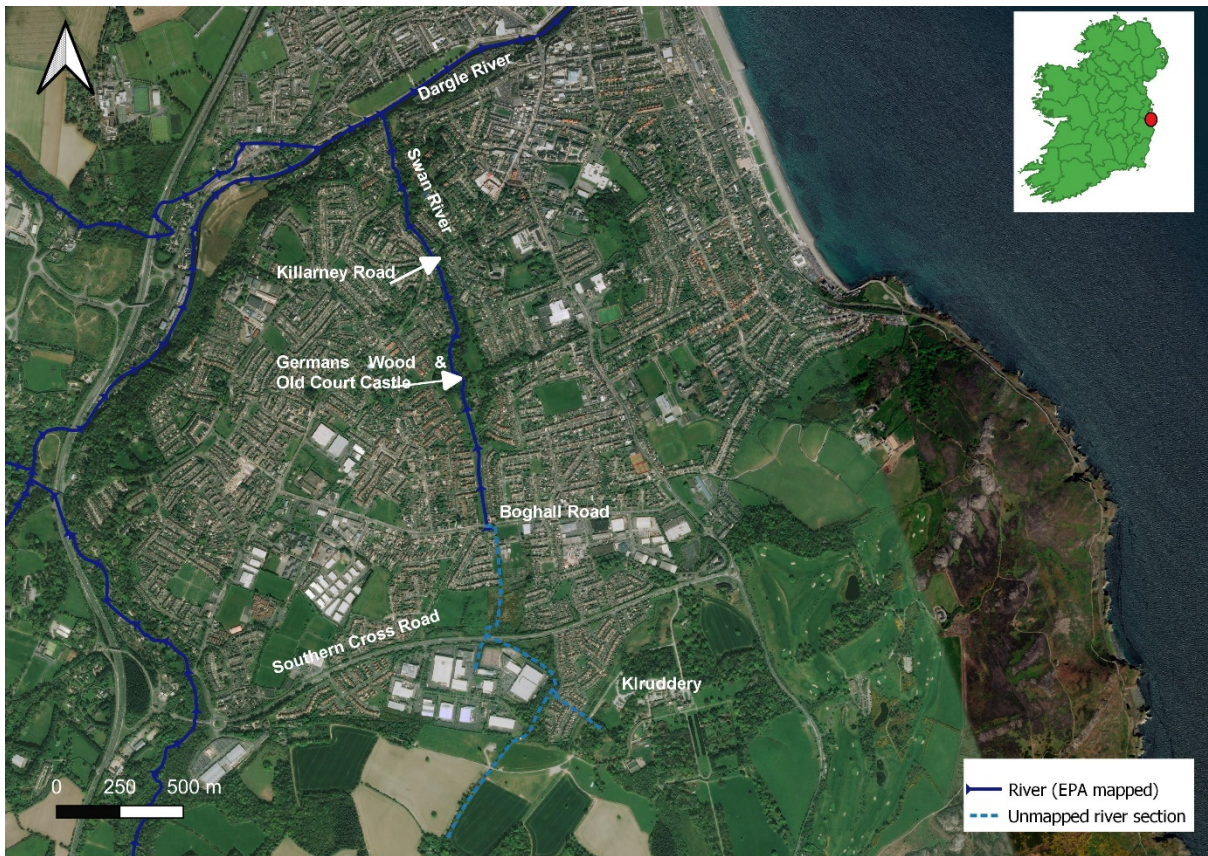
Figure 1-1: Map showing the course of the Swan River. The dashed line is an approximate outline of the unmapped sections.

Figure 1-1 below shows the location of the Swan River and the dashed line represents the unmapped section of the river.

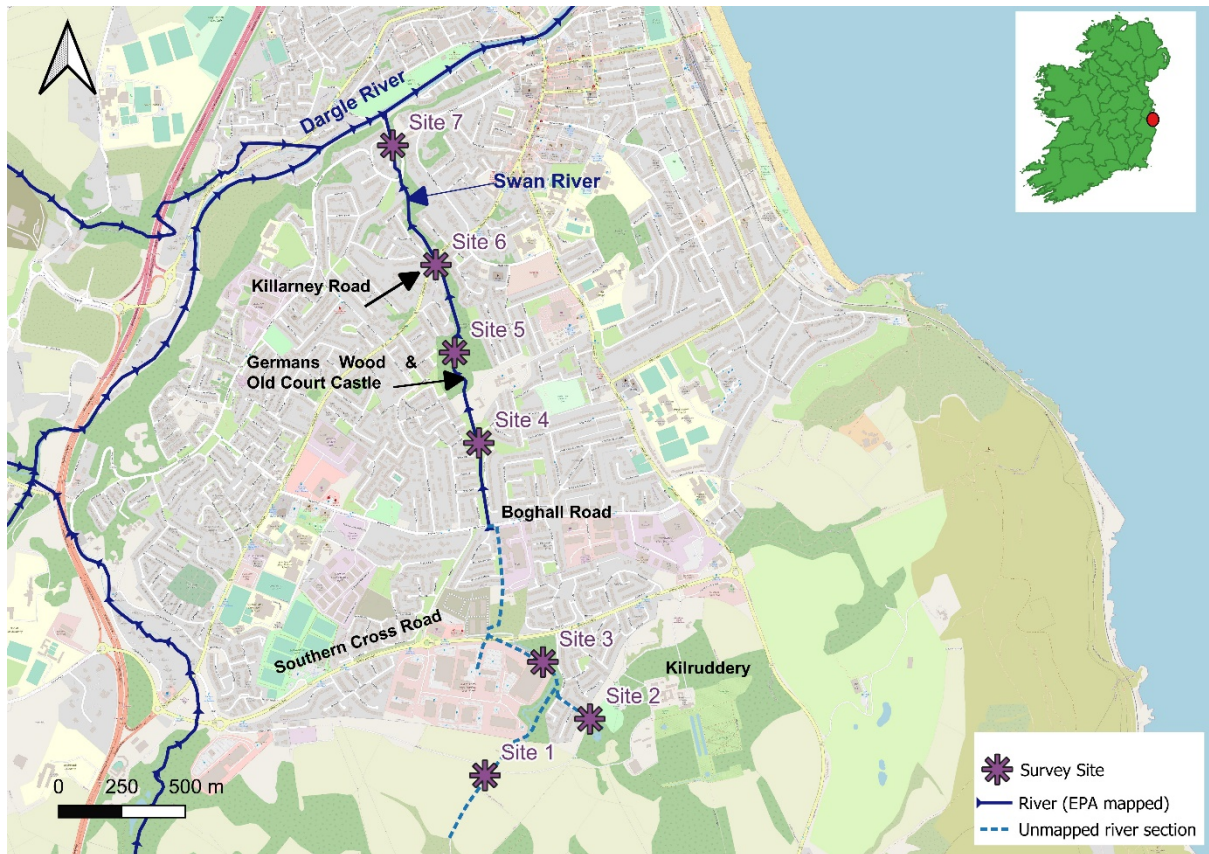
Figure 2-1: Map showing the location of sampling points along the Swan River.

Table 2-1 below gives the GPS coordinates for each survey site and **Figure 2-1** below shows a map of the sampling locations.

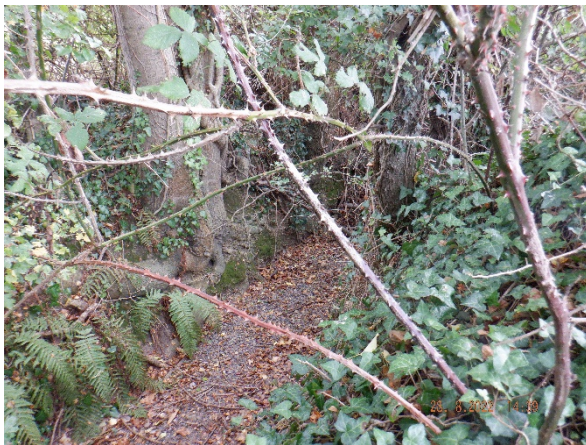
The main channel of the Swan at **Site 1** was completely dry at the time of survey. The channel here has been modified into straightened drainage channel with steep vertical banks and cut off from a floodplain. A narrow treeline (WL2) consisting of mature broadleaves line the top of both banks with an understory consisting of thick bramble (*Rubus fruticosus* agg.) with ivy (*Hedera helix*), ferns and dog-rose (*Rosa canina*). The surrounding land is tilled land (BC3) and improved agricultural pasture (GA1).

Plate 4-1: Main channel of the Swan River in Kilruddery estate which was dry at time of survey (Site 1).

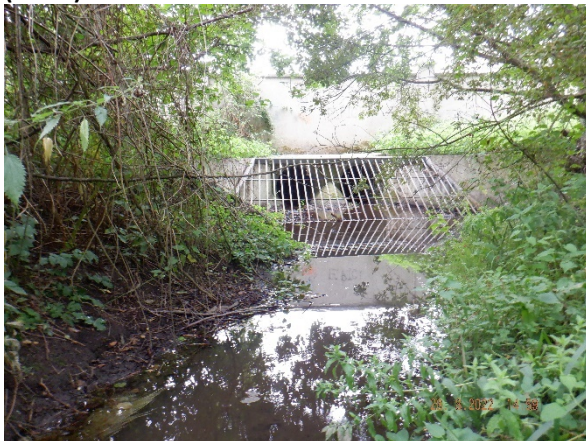
Plate 4-3: Culvert which the small tributary channel is diverted under Hollybrook estate (Site 2).

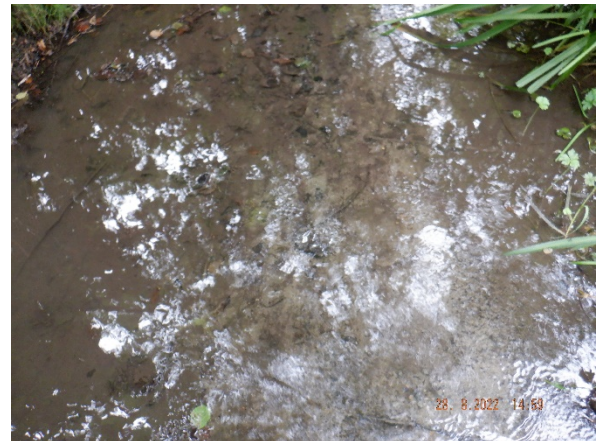
Plate 4-4: Silty substrate typical of Site 2.

Dissolved oxygen (DO) conditions at **Site 2** were 8.36mg/l and slightly lower further downstream at **Site 3** as the river flowed through Hollybrook (7.80mg/l). Although conditions observed were slightly low and not optimal for salmonids (require 9mg/l >50% of the time) they are not overly concerning. When DO falls below 6mg/l this can start to have deleterious effects upon salmonid fish dependent on the amount of time low levels are sustained for. When river bed sediments were disturbed, a foul smell was apparent indicating anoxic or low oxygen conditions within the stream bed.

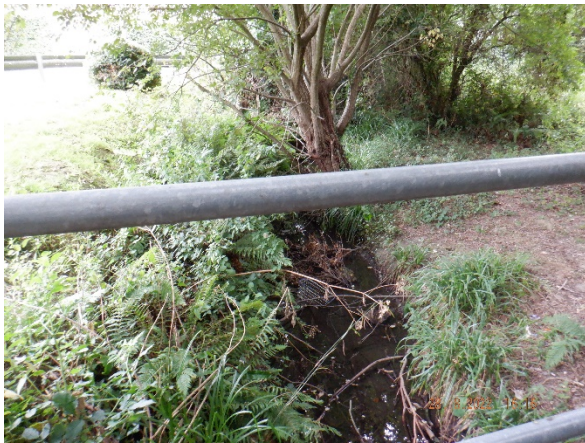
Plate 4-5: Swan River as it flows through Hollybrook estate (Site 3).

The Swan then reemerges and flows along the western boundary of Hollybrook estate (**Site 3**). The channel is narrow (1m width) and has been modified being straightened and deepened with 1-2m high banks. Instream characteristics were very uniform with little habitat heterogeneity or complexity which is required to create diverse habitats for a wider range of aquatic species and habitats. The flow was slow to stagnant with shallow water (0.2m) at the time of survey. The substrate consisted mainly of silt and it was difficult to walk along the river here as the silts were deep and sinking in sections. The channel is quite heavily shaded and no aquatic vegetation or algae was recorded with the exception of American skunk cabbage (*Lysichiton americanus*) which is listed a Third Schedule invasive species.

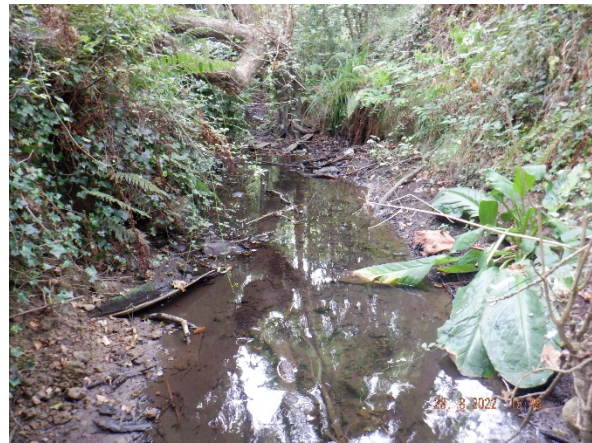
Plate 4-6: Silted substrate of Swan River as it flows through Hollybrook estate (Site 3).

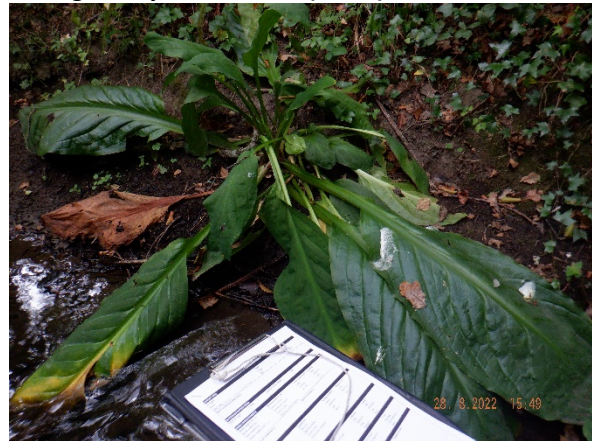
Plate 4-8: American skunk cabbage growing along the edge of the Swan River at Hollybrook estate (Site 3).

One single plant was identified at Hollybrook estate (53.18328, -6.11052) while numerous plants were present further downstream in Germans Wood just upstream of the weir (53.19382, -6.11552).

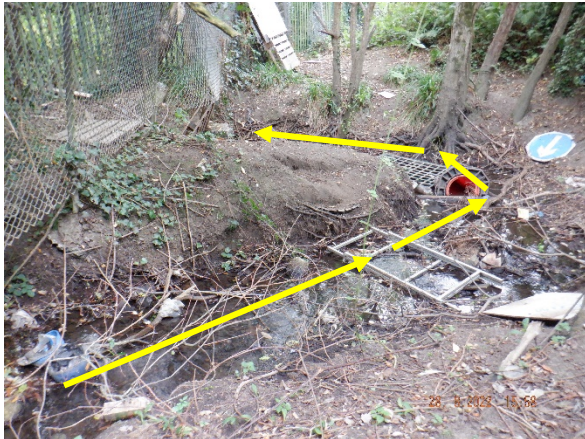
Plate 4-9: Section of the Swan River just before it is diverted under the industrial estate. Yellow arrows indicate direction of flow highlighting sharp turn the river takes (Site 3).

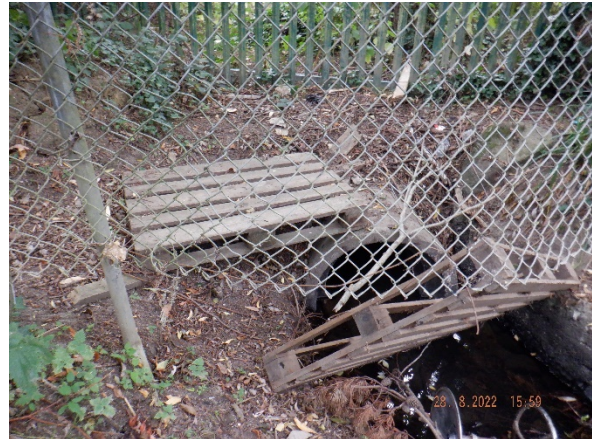
Plate 4-10: Close up of the pipe culvert which conveys the Swan under the industrial estate (Site 3).

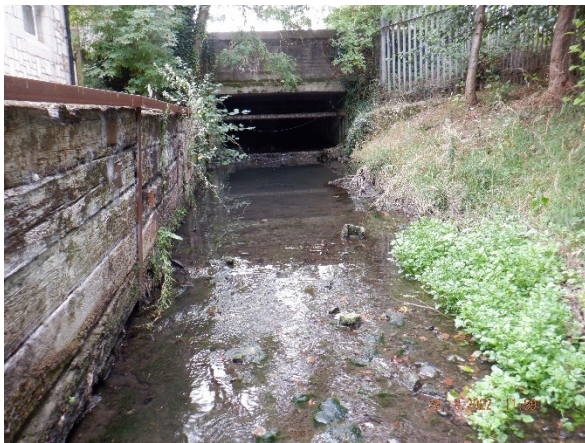
Plate 4-11: Swan River as it emerges from flowing under the Boghall road (Site 4).

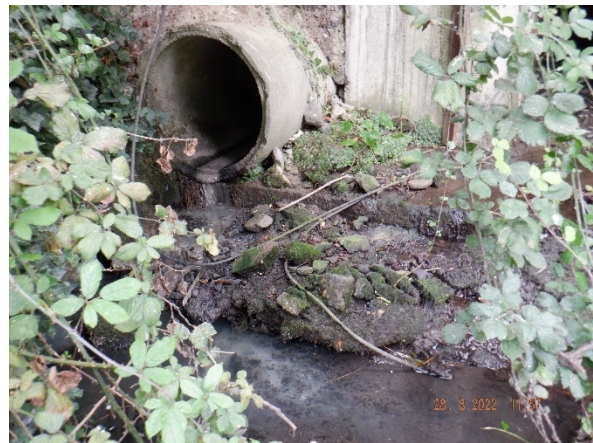
Plate 4-12: Pipe discharging grey water at the Boghall Road culvert.

The filamentous green algae growth indicates nutrient enrichment issues within the Swan River. Directly at the Boghall Road culvert there is a second pipe culvert and at the time of survey this was discharging grey coloured water (**Plate 4-12**). The water was coloured grey for approximately 20m downstream of this discharge. Dissolved oxygen conditions were quite low in this section of the river at 6.66mg/l. No sewage fungus was observed. Another pipe discharging grey water was observed along Site 5 downstream of the weir between the boundaries of Giltspur Wood and Glencourt estates again no sewerage fungus was observed here.

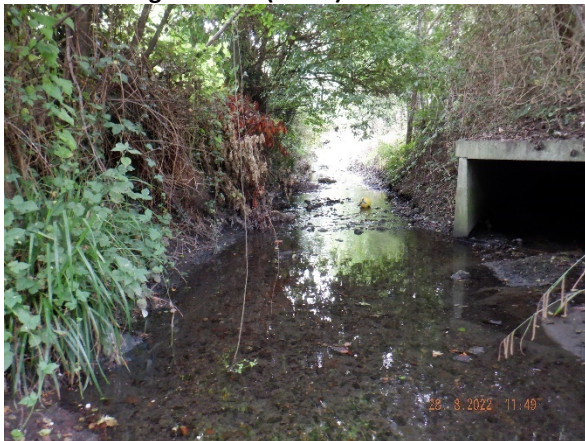
Plate 4-13: Swan River as it flows along Wheatfield estate, unmapped tributary can be seen entering via a culvert on the right (Site 4).

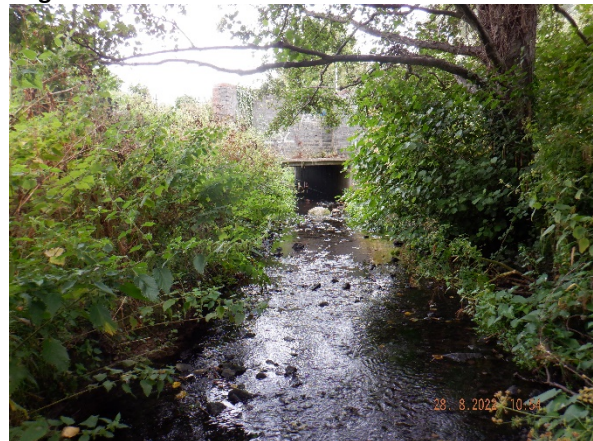
Plate 4-14: Swan River at Giltspur Brook (Site 4).

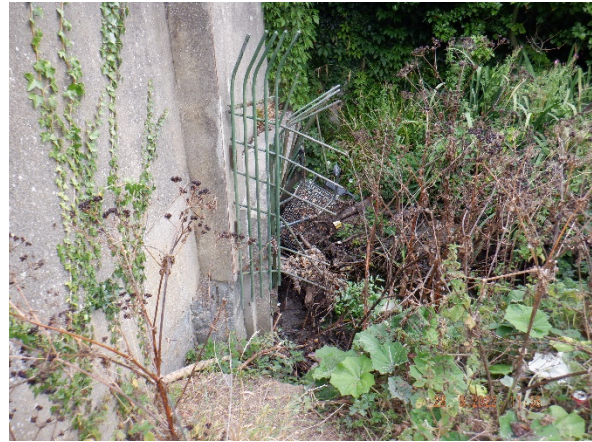
Plate 4-16: Pipe culvert where Swan River flows into Germans Wood

A tall wall divides Giltspur from the German Woods and the Swan flows through a small pipe culvert with rubbish built up at the trash screen. This culvert is undersized and together with the wall forms a barrier to movement for some wildlife to and from Germans Wood (e.g., small mammals such as hedgehogs).

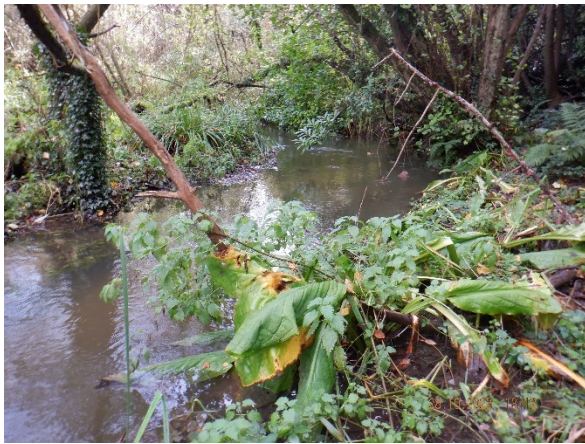
Plate 4-17: Swan River in German Woods just upstream of the weir. American skunk cabbage is seen growing in the foreground (Site 5).

A large weir is present just downstream of the Old Court Castle ruins. The main structure is approximately 3m high with a small amount of flow directed through two outfalls at the top. The main flow of the river at the time of survey was directed through a short mill race and cascades down bedrock to the river below. The weir has slowed and impounded water upstream creating a wide waterlogged area where wet willow woodland has formed (WN6). American skunk cabbage is again present here and is quite common upstream the weir.

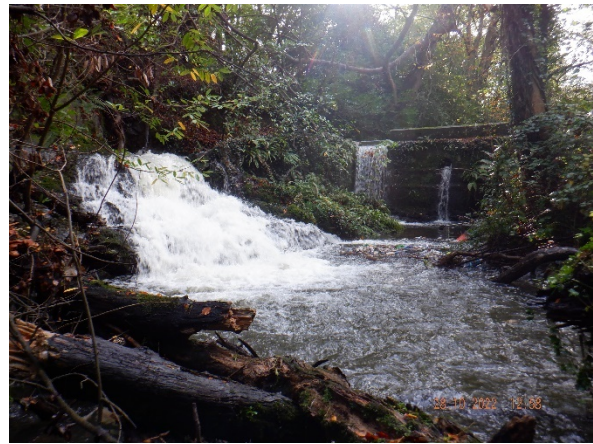
Plate 4-18: Weir at Germans Woods. The main flow on the left is over bedrock (Site 5).

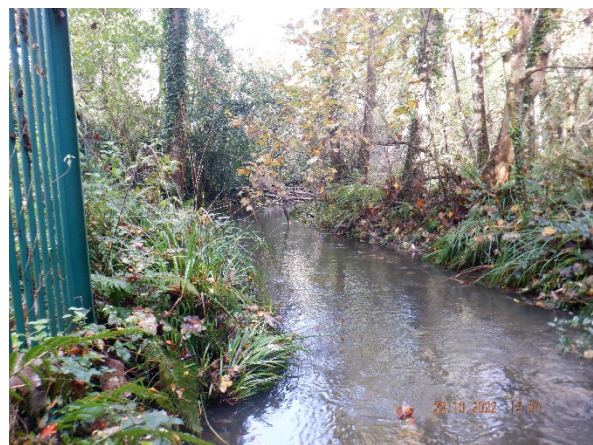
Plate 4-20: Swan River downstream of the weir in German Woods (Site 5).

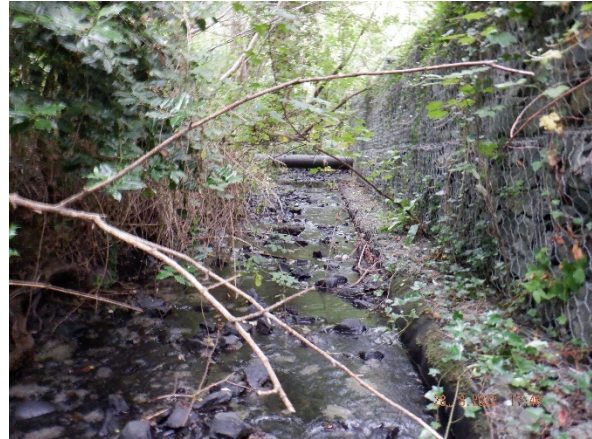
Plate 4-22: Gabion baskets and concrete reinforcement along the bank as the river flows past Glencourt estate (Site 6).

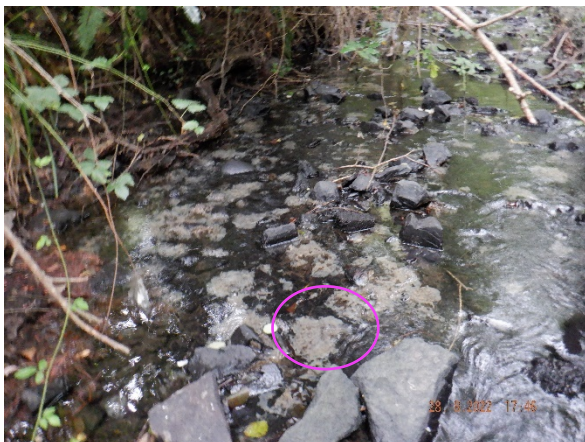
Plate 4-23: Typical substrate of the Swan in the lower reaches with pink circle highlighting freshwater sponge (Site 6).

Very little aquatic plants were observed growing instream with common water-plantain (*Alisma plantago-aquatica*) and the liverwort *Conocephalum* sp. observed only at Site 7. The distinctive red encrusting algae, *Hildenbrandia* sp. was present throughout the lower reaches which grows well in shaded conditions. In addition, freshwater sponges were very common growing on the cobbles and boulders throughout the lower sections of this river (see **Plate 4-23**, **Plate 4-27** and **Plate 4-28**)

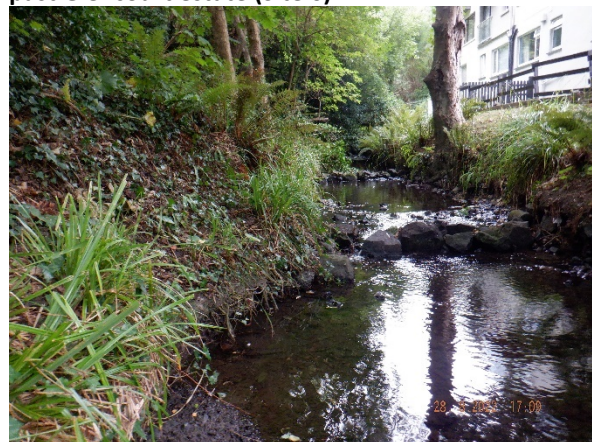
Plate 4-24: Swan River just before it flows under Killarney Road with small rock weirs (Site 6).

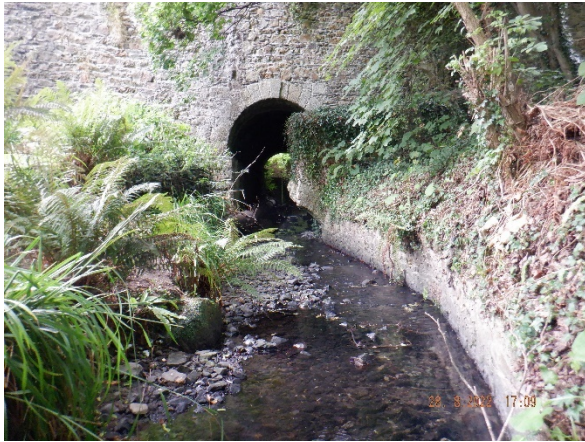
Plate 4-25: Swan River as it flows under Killarney Road (Site 6).

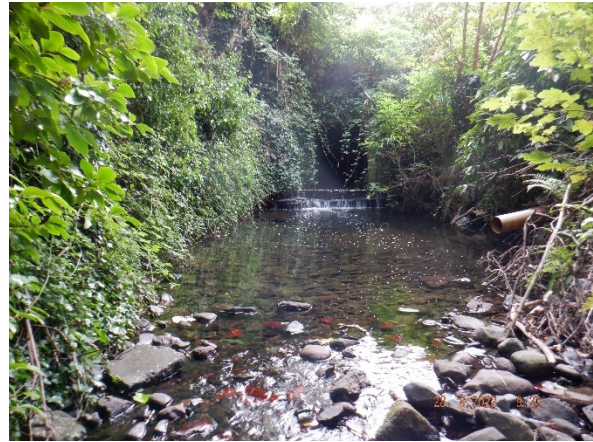
Plate 4-26: Swan River with weir and culvert at Glenwood estate just visible in background. Red coloured substrate are cobbles with the encrusting algae, *Hildenbrandia* sp. (Site 7).

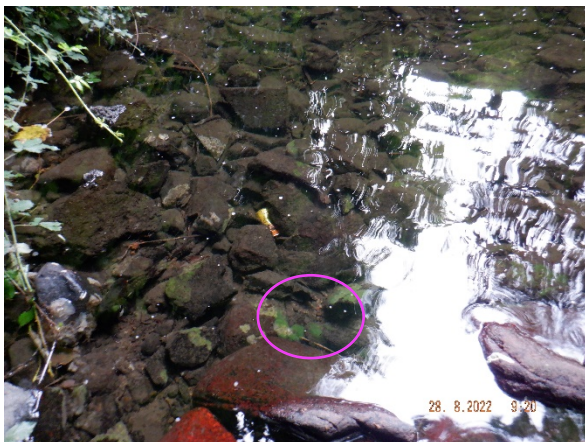
Plate 4-27: Typical substrate in the lower reaches with pink circle highlighting freshwater sponge (Site 7).

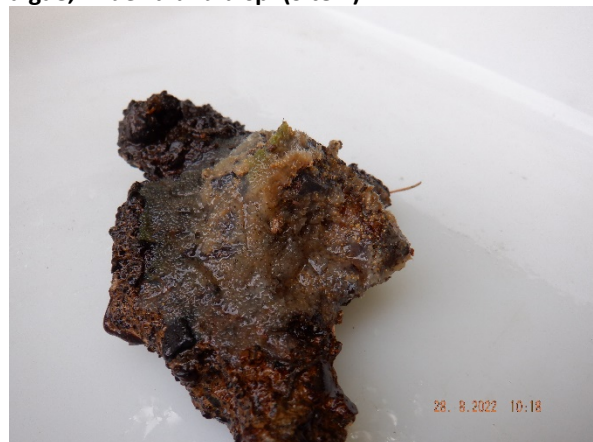
Plate 4-28: Close up of freshwater sponge on top of a cobble.

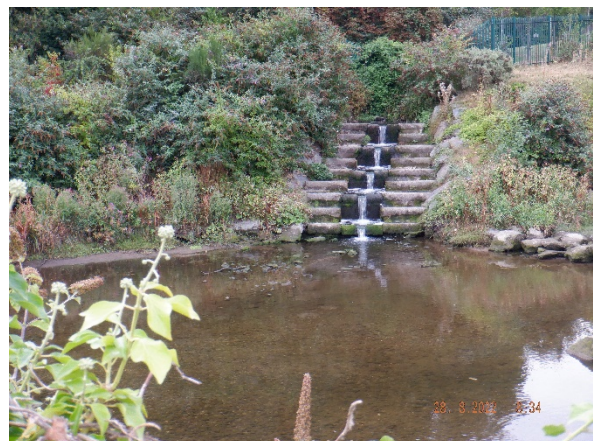
The Swan River enters the Dargle River via a large stepped weir (**Plate 4-30**).

Plate 4-30: Weir the Swans confluence with the Dargle river.

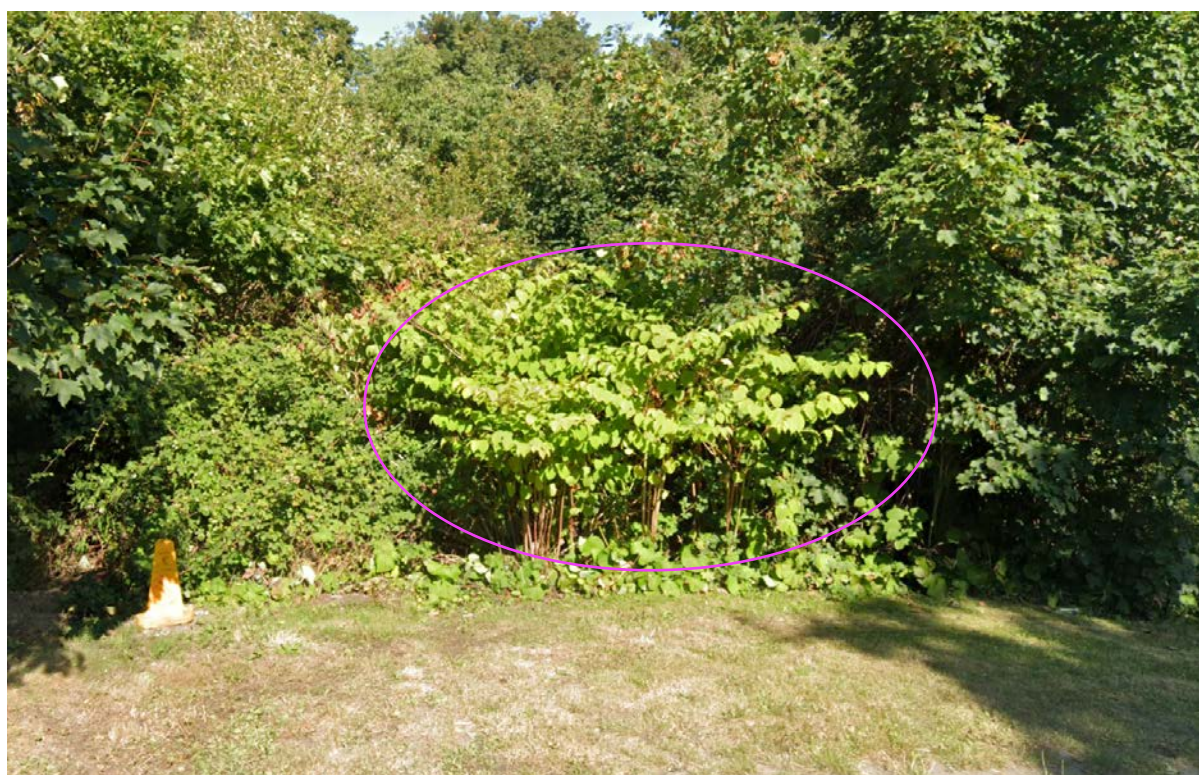
Plate 4-31: Pink circle highlights Japanese knotweed identified close to the Swan River. (image courtesy of google street view Aug 2022).

Knotweed spreads easily when disturbed via fragmentation of rhizomes (underground modified stems) and should not be cut or trimmed as a control method. It should be treated using proper application of herbicides approved for use near water by a qualified user.

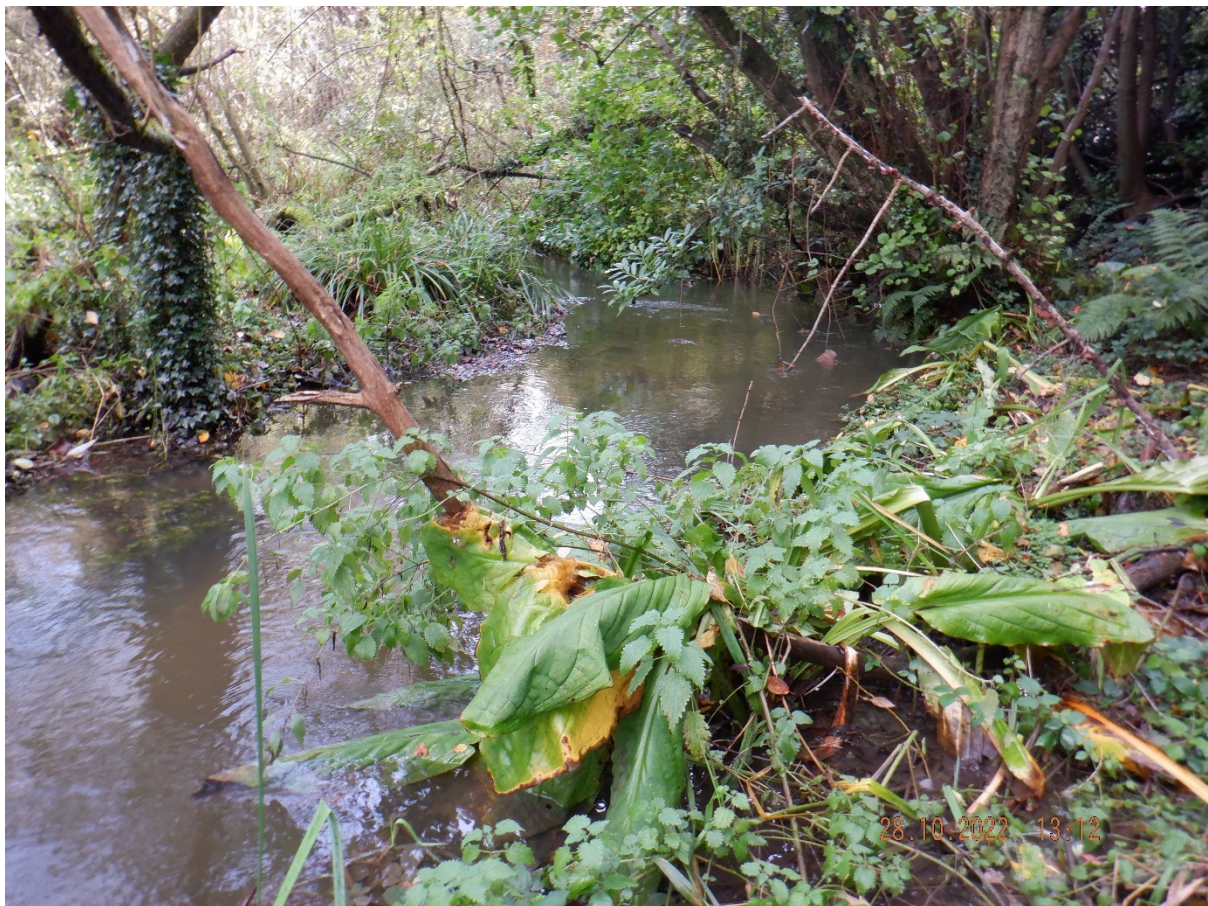
Plate 4-32: American skunk cabbage in wet woodland area of Germans Wood.

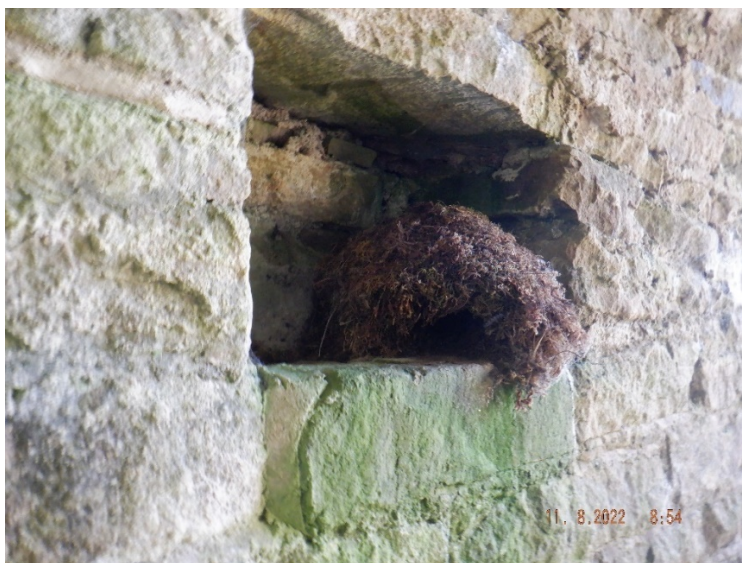
Plate 5-1: Example of a dipper nest under a bridge in the midlands. The dipper has used a cavity in the wall as a ledge to form the nest

Dippers and grey wagtails can be encouraged to the Swan by the placement of nesting boxes. These birds often nest in cavities under bridges and culverts (see **Plate 5-1**). The Swan is intersected many of these structures but they lack the cavities which dipper or grey wagtail can use to make a nest. Artificial nest boxes can be placed under these structures to encourage nesting.

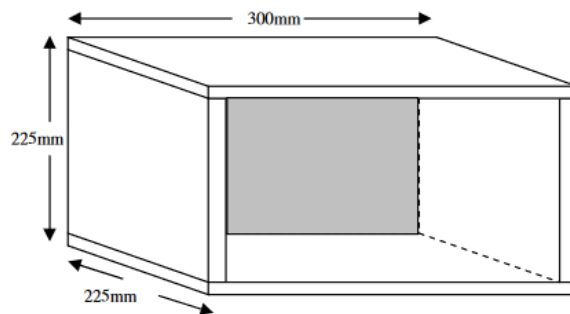
This open-fronted nestbox (Fig 1) can be used where there is no cover above the proposed site (e.g. on the outside of a bridge parapet or where the bridge deck may be open). For ease of fitting, a back can be added to the box, made from a sheet of plywood or hardboard, or small metal brackets can be positioned as appropriate. A lip, no more than 50mm (2") high, can be added to the front of the box.

Figure 1: Dipper nesting box

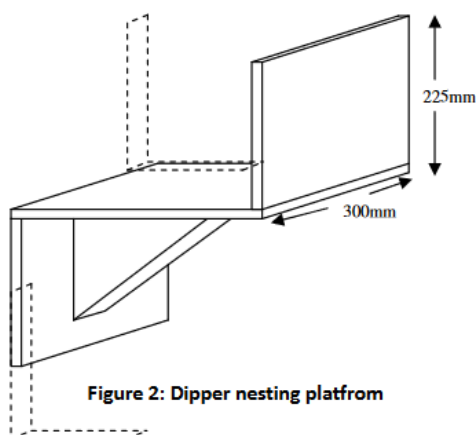
The platform (Fig 2) is designed for use under bridges where it will be sheltered from the weather. Its shape allows it to be fitted to vertical pillars or abutments, the underside of horizontal spans, or anywhere along the curves of an arch (Fig 3). The boards should all be the same shape and size. Depending upon the location, fixing can either be with a timber backboard (as illustrated) or with metal brackets (also illustrated – dotted lines). Similarly, the addition of brackets may be needed to support the boards depending upon position of fixing.

Figure 2: Dipper nesting platform
