A Condition Assessment of Trees Located at the Western End of
'Duncairn Terrace' to the Front of 'Tesco Express', Quinnsboro
Road, Bray, Co. Wicklow.

Prepared for: Bray Tidy Towns Committee

Prepared by: Felim Sheridan (F.Arbor.A, RFS Dip. Nat. Dip & NCH in Arboriculture)

Date: 15th March 2021

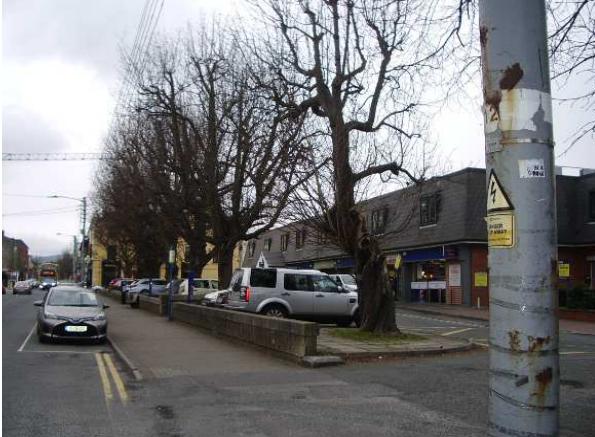
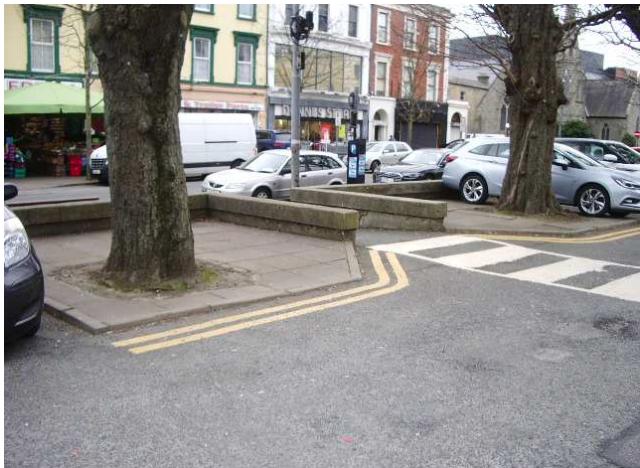
Tree No	Tree Species	Age Class	Phy Con	Structural Condition / Comments	Recommendations
				Phy = Physiological	
0725	Horse Chestnut <i>Aesculus hippocastanum</i>	Mature	Fair / Poor	<p>Poor</p> <p>It is growing within a paved area and was initially twin-stemmed from a height of c. 1.6m up; however, one stem has broken out from this point, leaving its crown very asymmetrical as a result. There is a large area of decay on the main trunk at this tear wound and this decay is progressing into the main trunk creating an unstable tree. Its crown size has been reduced in the past and is re-growing from this to its current size. There are some areas of liquid exudation/ bleeds present on the main trunk indicating towards infection by 'Bleeding Canker' of Horse Chestnut.</p>	<p>I would recommend its <u>removal</u> as the most appropriate management option.</p> <p>Remove stump and replant with a new tree.</p>

- 5.1 From our assessment of these seven trees, we are now recommending the removal of **Tree Nos. 0725 & 0729** both mature Horse Chestnut trees due to serious structural issues caused by decay within their lower main trunks and bases. It is our professional opinion that the decay in both these trees is very advanced and pruning to address these issues would have a negative impact on them visually, and it would still be necessary for their removal short-term solution. I would recommend their removal now including their stumps along with replacement tree planting into this line of trees so as to help rejuvenate the tree line and to secure it for the future.
